FACILITY COMPLIANCE INSPECTION REPORT

Division of Waste Management Solid Waste Section

Alamance County Closed MSW Landfill
3066 Alfred Road
Swepsonville, NC 27359

Post Closure Inspection

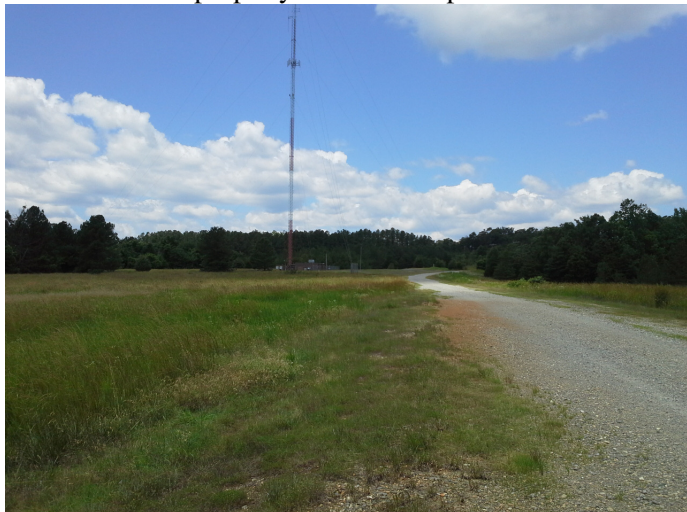
Radio tower on property and view of pre-1991 area

15. The landfill cap is covered with native grasses and is mowed annually in the fall.
16. There is a radio tower on site, prior to the fill area, with a small storage building/structure.

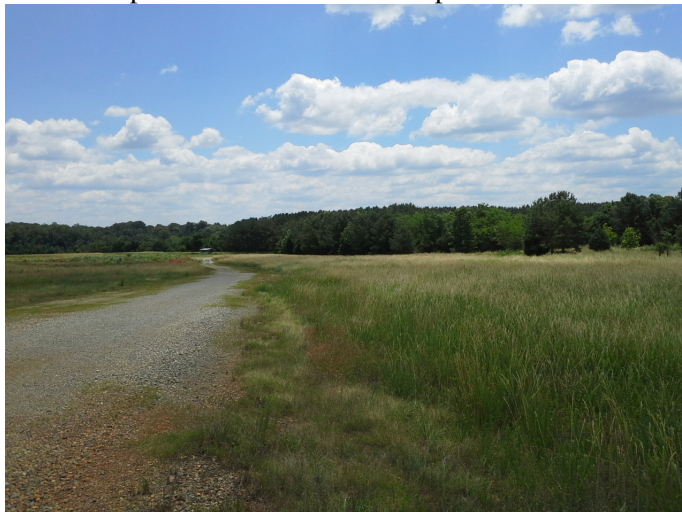
View of pre-1991 area towards carport-like structure

17. Alamance County has approved the use of an area of the landfill (cap) for a local model airplane flying club to fly planes. A carport-like structure designates the general area of use.

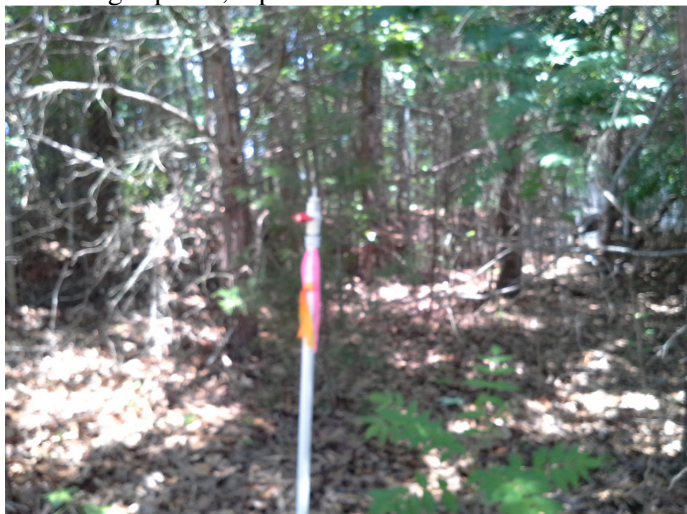
Landfill gas probe, representative

9. There are a total of 21 landfill gas (LFG) probes installed, constructed of ¾ inch PVC pipe.
10. Mr. Thomas stated that all of the landfill gas wells are labeled and have stopcock valves.

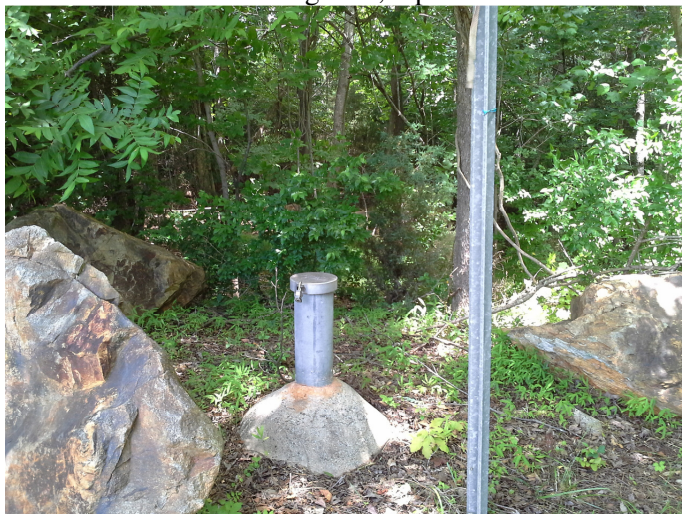
Groundwater monitoring well, representative

6. Edge of waste markers have been installed.
7. The facility maintains semiannual groundwater and surface water test records collected by Buxton Environmental, Inc. Records for groundwater and surface water were verified for March 28, 2013, September 6, 2012, March 13, 2012, September 12, 2011, March 14, 2011, and September 16, 2010. Test records note an exceedance.
